INVESTIGATIONS OF A BEARING FAULT DETECTOR
FOR RAILROAD BEARINGS

Donald S. Wilson

Shaker Research Corporation
Northway 10 Executive Park
Ballston Lake, N.Y. 12019

Prepared Under Contract No. NAS8-31449

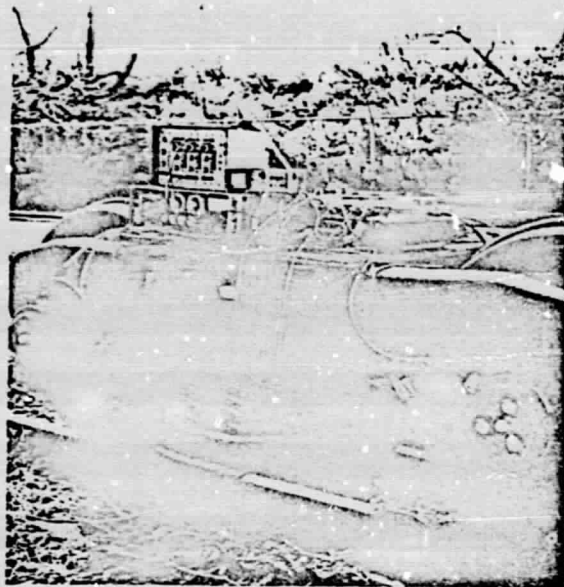
Fig. 15 Instrumented Axles Installed on Truck

Each axle was instrumented and tested in the grease test machine in the same fashion. Axles 1 and 2 were also installed on a truck utilizing the same instrumentation arrangement and pushed down a test section of track. The instrumentation was carried on the truck during these tests as illustrated in Figure 15. The truck was pushed by hand with forward speeds below 5 mph. Accelerometers were then switched to the underside of the truck and the sound meter placed along the side of the track. The truck was then pushed down the track and data collected during pass by of the truck over the accelerometer location.

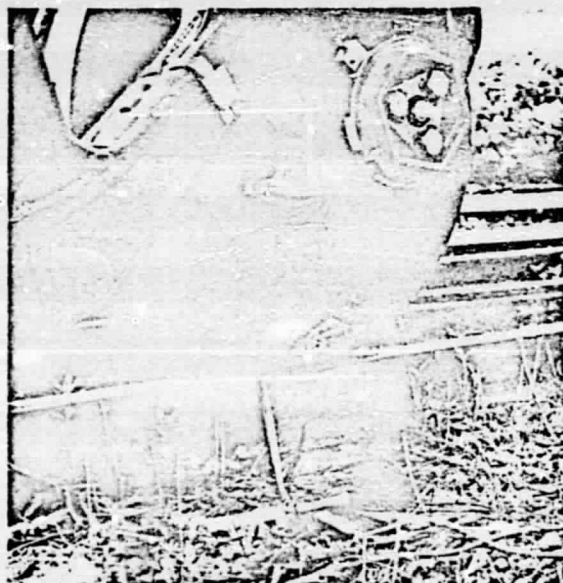
Fig. 16 Track Instrumentation for Roll-By Tests

Figure 16 illustrates the wheel passing over the location of the accelerometer. Under close examination the accelerometer pickup may be seen
